# Bike Boxes at Signalized Intersections

*Principal Investigator:* Dr. Jennifer Dill, Portland State University  
*Co-principal Investigator:* Dr. Christopher Monsere, Portland State University  
*Graduate Research Assistant:* Nathan McNeil, MURP, Portland State University

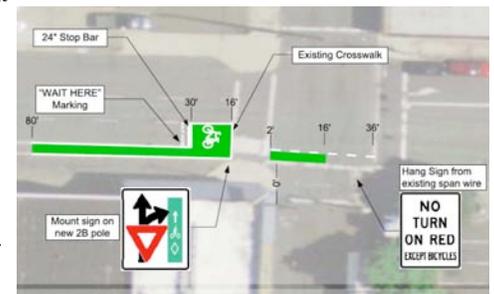
Typical Bike Box Layout:

Bike boxes are meant to place cyclists at the front of the queue during red light phases. Motorists wait behind the bike box - cyclists should be more visible. However, bike boxes are not effective during the green light phase.

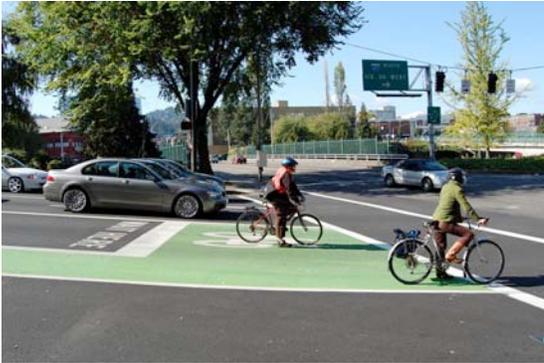
PBOT installed Green Bike Boxes at 11 location in Portland, including this one at West Burnside and 14<sup>th</sup> Avenue.

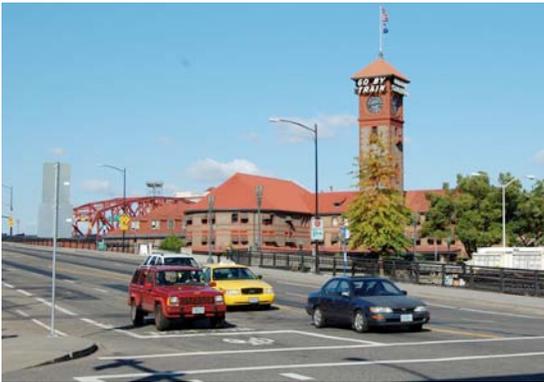
PBOT installed three uncolored bike boxes. This one is at NW Broadway and Hoyt.

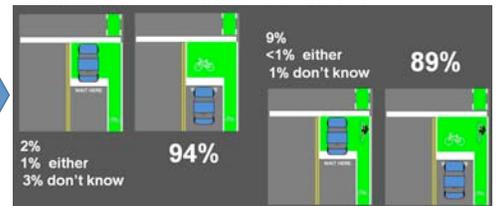
**Motorists:** If you approached an intersection with a red light, where should you stop your car?

Motorists understood that they should stop prior to the bike box.

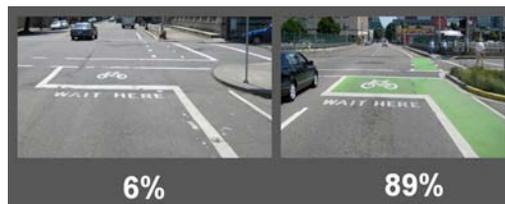
**Motorists:** As a driver, do you think one of the pavement marking designs is better than the other?

**Motorist color preference:** Motorists preferred the green bike boxes to the uncolored bike boxes..

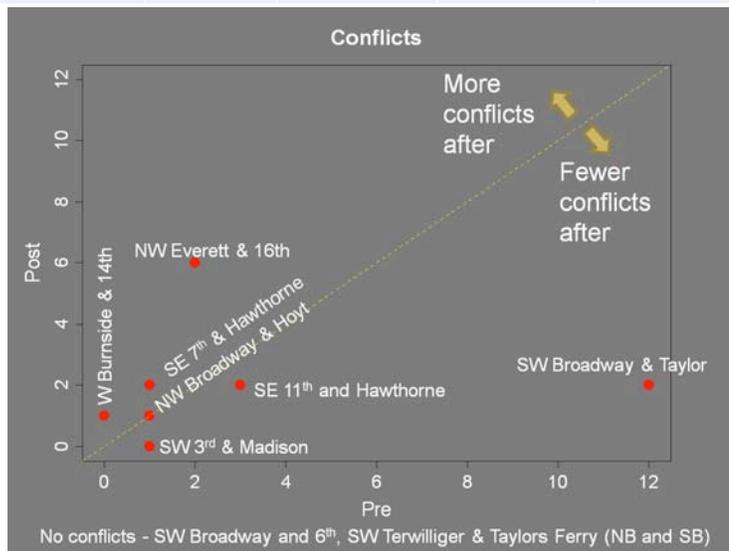
Overall, the number of conflicts was lower in the after period, however no significant difference was noted. Most Conflicts were minor in nature. The chart shows that conflicts at some locations increased slightly while conflicts at other locations decreased slightly. Currently further analysis of the video is being carried out in an effort to gather more conflict points.

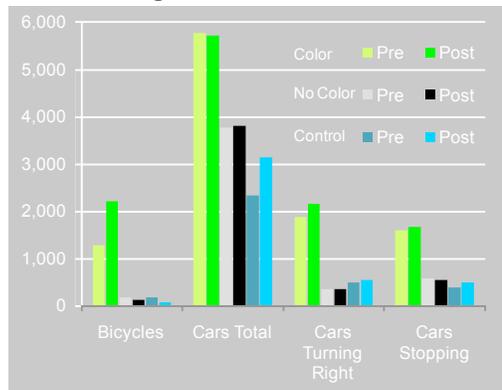
Count Changes

The number of cyclists increased in the after period, while the number of cars remained steady

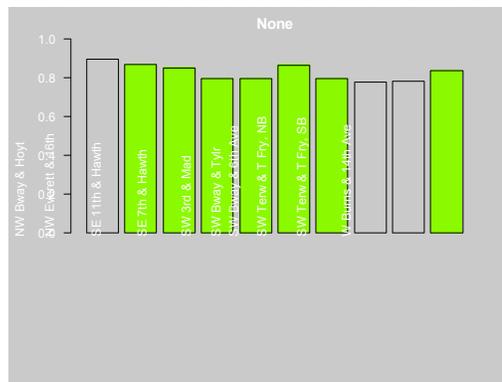
Motor Vehicle Encroachment in Bike Box

When stopping for a red light, fewer than 20% of the motorist entered the bike box.

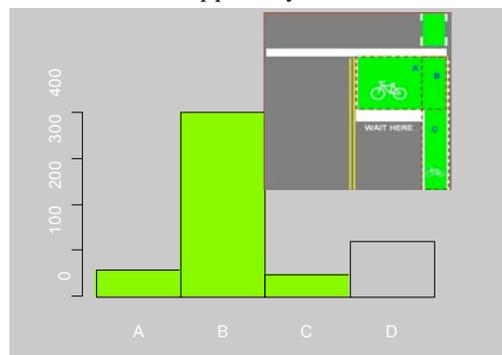
Location of Stopped Cyclist in Box

When stopped at red lights, most cyclists stopped in the bike lane and ahead of the motorist stop bar
